## A quick and simple technique to aesthetically restore an anterior tooth with severe Molar-Incisor Hypomineralisation (MIH)

BY DR.  
PATRICK  
ROUAS  
(FRANCE)

### CASE STUDY

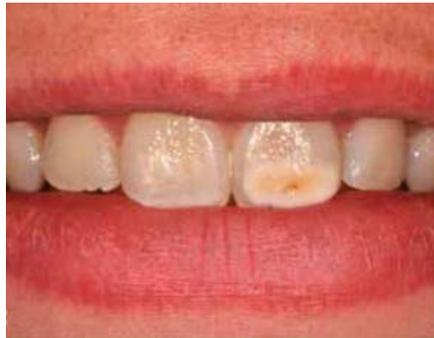
Lola is a 14 years old patient who wanted to improve her smile. Her upper left central is severely affected by molar-incisor-hypomineralisation (MIH). Affected tooth has an unsightly stain which affected her self-esteem when she smiled (Fig 1). There was also some slight loss of enamel structure on the labial surface.

Upper left central with MIH. (Fig 1)

Fig 1. Upper left central with MIH.

The first treatment consideration was to use resin infiltration, Icon (DMG) to address this lesion but because the hypomineralisation was too deep this technique was deemed ineffective. The most ideal approach was to use macro-abrasion followed by a thin layer of composite material especially designed to replace loss tooth structure.
