A quick and simple method to aesthetically repair a failing posterior Class II cavity

BY
DR GRAEME
MILICICH

CASE STUDY

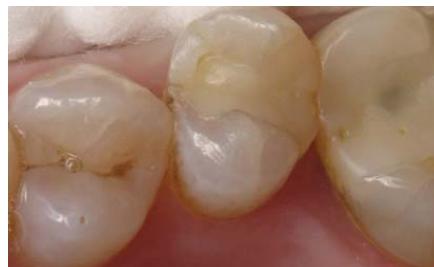
Failed composite restoration. The colour of the enamel in the tooth matched Aura E1 shade. (Fig 1)

Fig 1. Failed composite restoration.

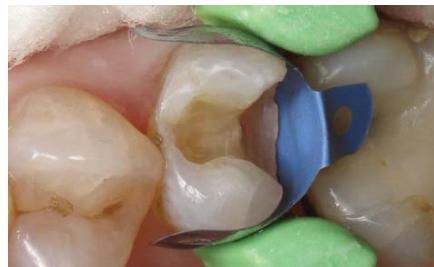
Fig 2. Following removal of the decay.

Following removal of the decay, the enamel margins were bevelled, the tooth air abraded, a V3 matrix and V3 ring were placed. (Fig 2)

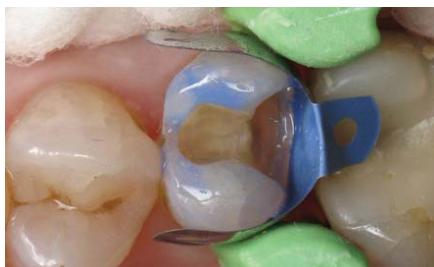
Fig 3. A self-etching bonding system was to be used.

A self-etching bonding system was to be used, hence, to ensure good bond to the enamel, the enamel margins were selectively etched for 15 seconds. Washed & dried. (Fig 3)

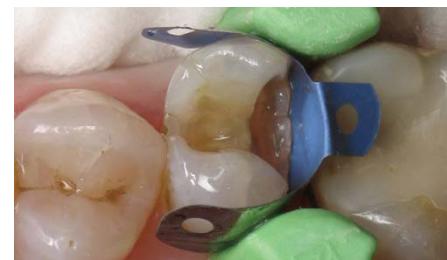
Fig 4. A self-etch primer was scrubbed into the dentine for 20 seconds.

A self-etch primer was scrubbed into the dentine for 20 seconds, air dried, the bonding resin applied and cured. (Fig 4)

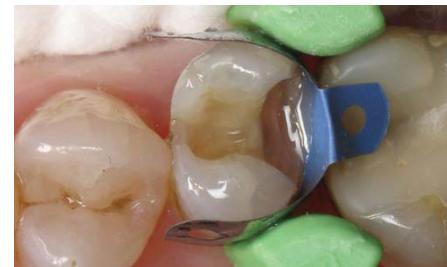
Fig 5. A radio-opaque flowable such as Wave (SDI Ltd.) was placed.

A radio-opaque flowable such as Wave (SDI Ltd.) was placed over dentin and cavo margins to a thickness of 0.5mm. This layer should be considered a part of the dentin hybridization process rather than restoration build up. (Fig 5)

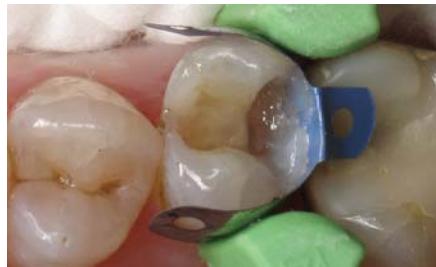
Fig 6. The interproximal wall was incrementally built up.

The interproximal wall was incrementally built up with Aura E1 shade. This was achieved by placing a thin layer, then sectioning it vertically to prevent C-Factor shrinkage stresses damaging bonds to the axial wall margins. (**Fig 6**)

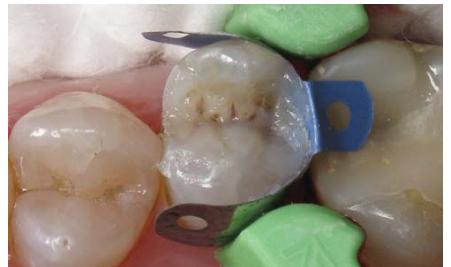
Fig 9a. Aura E1 shade was then used to create the palatal enamel.

Aura E1 shade was then used to create the palatal enamel and contoured to fissure pattern. (**Fig 9a**)

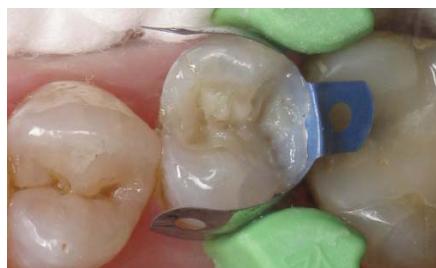
Fig 7. Then a 1.5mm dentine layer using Aura DC4 was placed.

Then a 1.5mm dentine layer using Aura DC4 was placed. This was then sectioned along the fissure pattern to effectively create multiple increments to help control C-Factor shrinkage stresses. (**Fig 7**)

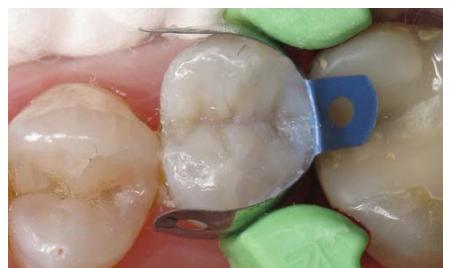
Fig 9b. Buccal enamel was then replaced with Aura E1.

Buccal enamel was then replaced with Aura E1, contoured to fissure pattern. (**Fig 9b**)

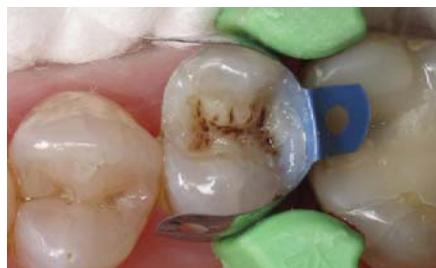
Fig 8. A dark brown tint was placed in the depths of the dentine.

A dark brown tint was placed in the depths of the dentine fissure pattern. (**Fig 8**)

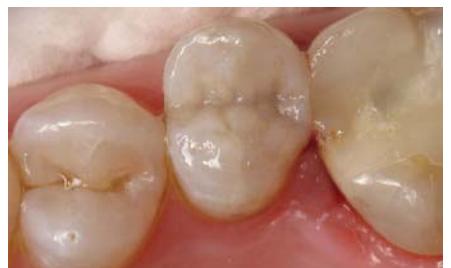
Completed case. Good match between enamel and the Aura E1 enamel shade. Margins match really well. (**Fig 10**)

Fig 10. Completed case.
